Efficiency and Effectiveness of Sprinkler Systems in the United Kingdom: An Analysis from Fire Service Data

May 2017

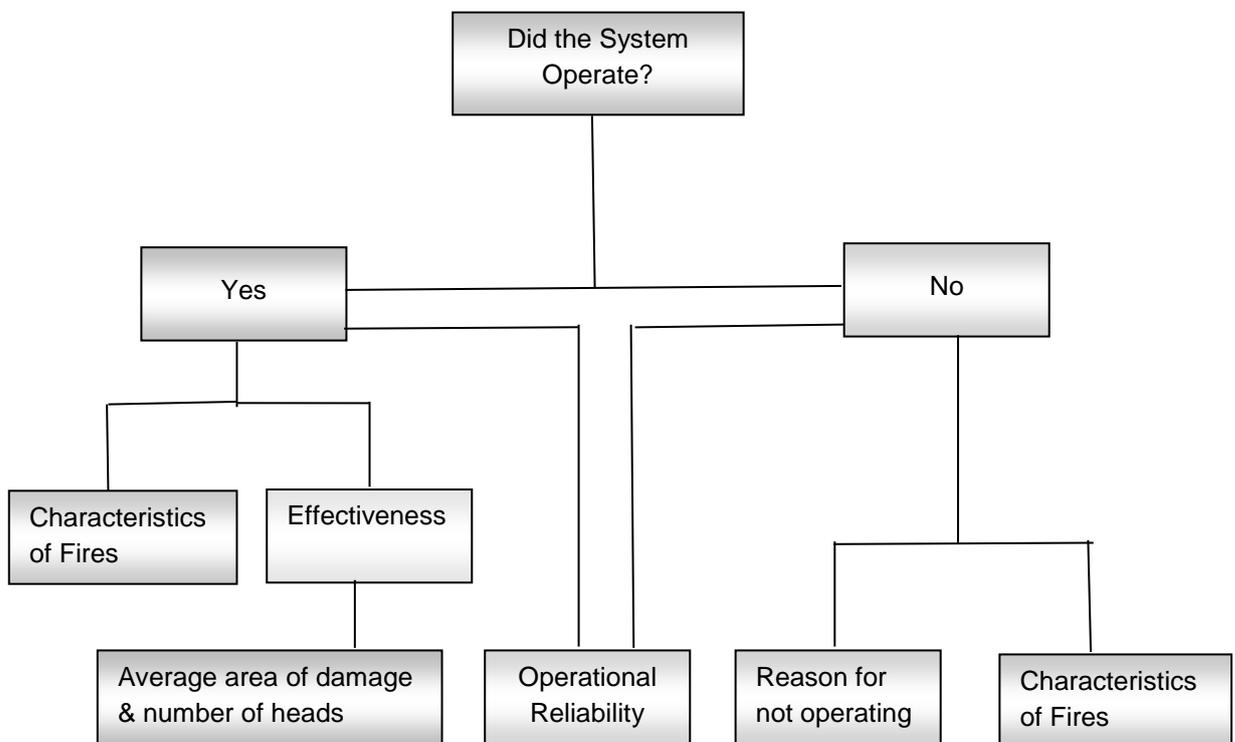
Figure 4: Framework for Analysis

2.2.3 The framework for the analysis is shown in Figure 4 and starts with the key question of whether the system operated. If the system did operate then the analysis establishes the characteristics of the fires e.g. where the fire was in relation to the sprinkler system (e.g. in the same room, on a different floor), how many heads activated and the extent of damage. The average area of damage and the average number heads activated are also estimated for those records where both the number of heads and area of damage has been provided. The impact of sprinklers on the fire (e.g. extinguished, contained/controlled) is analysed which enables the performance reliability or effectiveness of the system to be assessed.

- 2.2.4 If the sprinkler did not operate, the analysis considers the location of the fire in relation to the sprinklers and the reasons why the sprinkler did not operate. Where the system did not operate the analysis considers whether there are reasons that it could *not* be expected to operate e.g. because there was insufficient heat to activate the sprinkler heads. In assessing the operational reliability of the system the analysis takes account of circumstances where the sprinkler system could not be expected to operate.

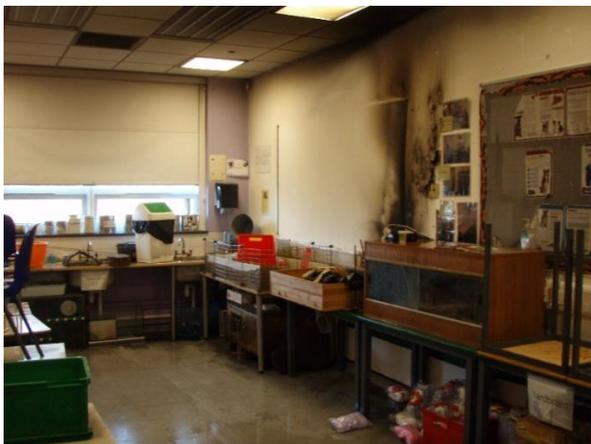
An electric heat lamp in the animal care classroom of a Newcastle school malfunctioned causing a fire with over 200 people on-site.

One sprinkler head activated which confined the damage to the room of origin and extinguished the fire.

A number of small animals were in the room involved and all survived whilst no other areas of the school were affected. Damage was limited to a wooden bench and minor smoke damage amounting to less than 1% of the whole building.

Damage was repaired quickly.

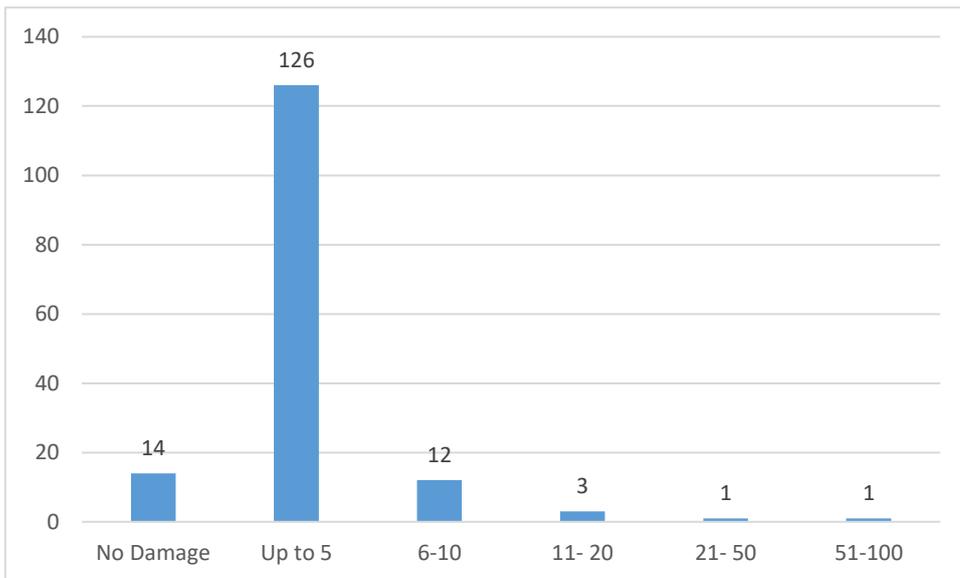
Figure B5: Number of Dwelling Fires by Area of Fire Damage, sq. m.

In terms of the area of fire damage where the sprinklers operated, data are available for 157 of the 276 fires. The number of fires by area is shown in Figure B5. Some 89% of fires had less than 5 sq. m. of fire damage.
